2017 RED RIVER WATERWAY PRIORITY REPAIR LIST

Prepared by Joel Brown
16 Sept 2017

HIGH PRIORITY AREAS OF CONCERN FOR ROCK REPAIRS

2017 RED RIVER PRIORITY REPAIR LIST

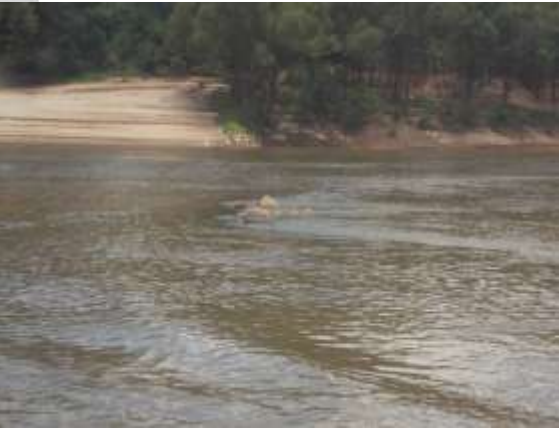
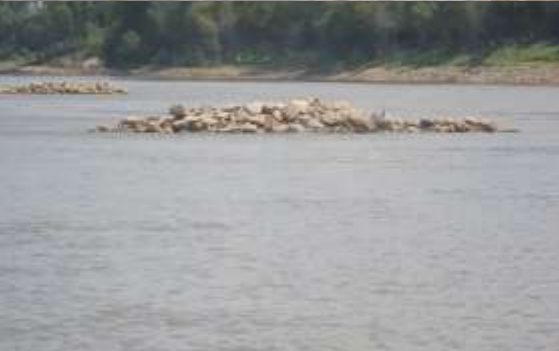
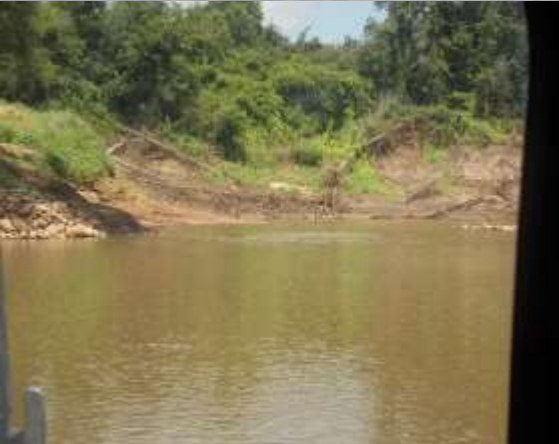
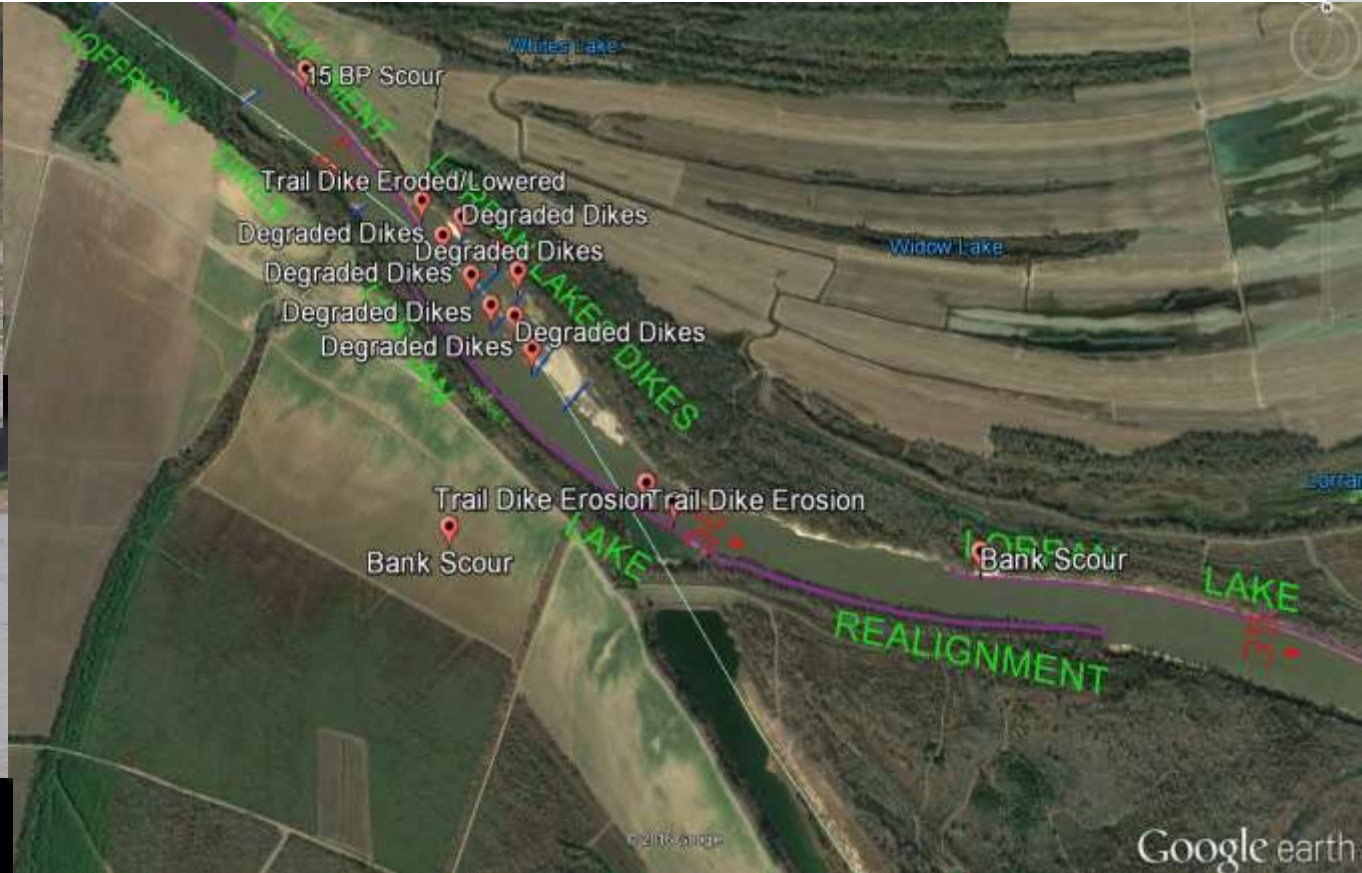
LORRAN/LORRAN DIKES

RM 36.8 TO 35.4-R AHP

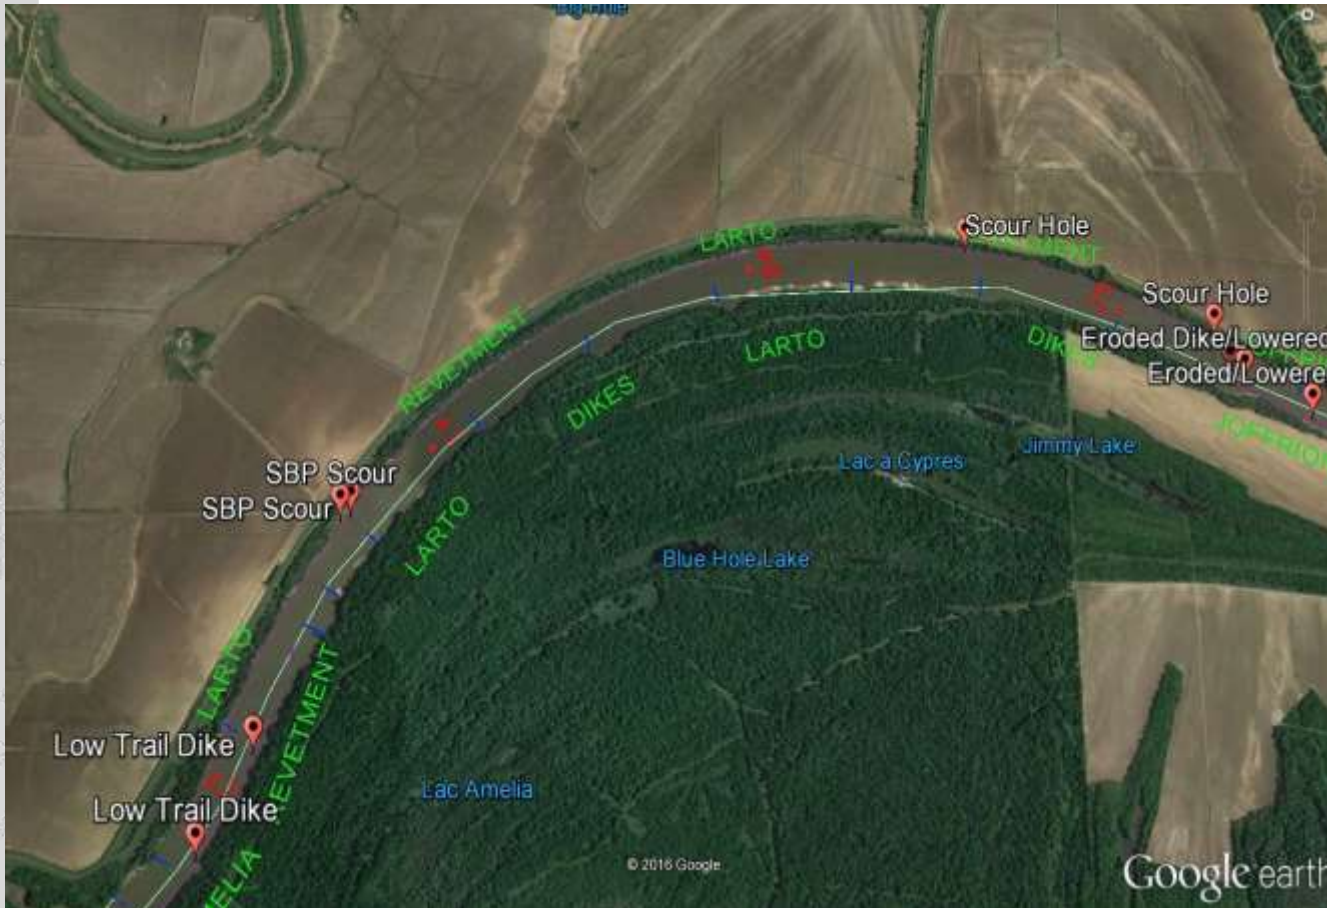
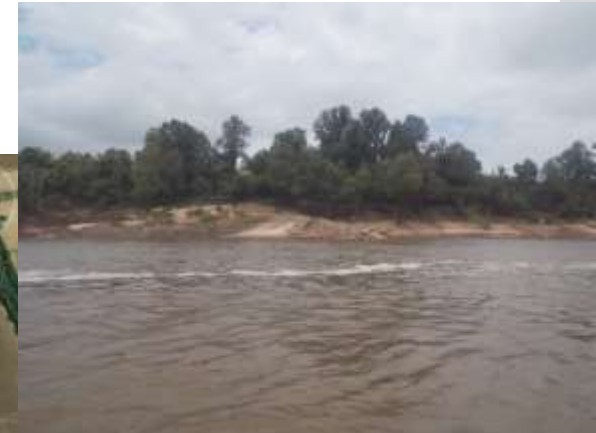
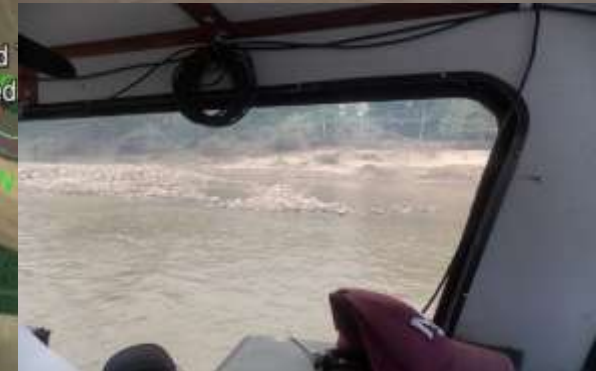
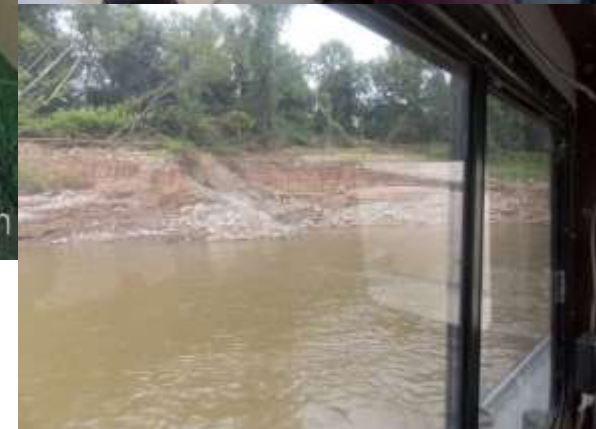
LARTO/LARTO DIKES

RM 42.1 TO 38.7-L AHP

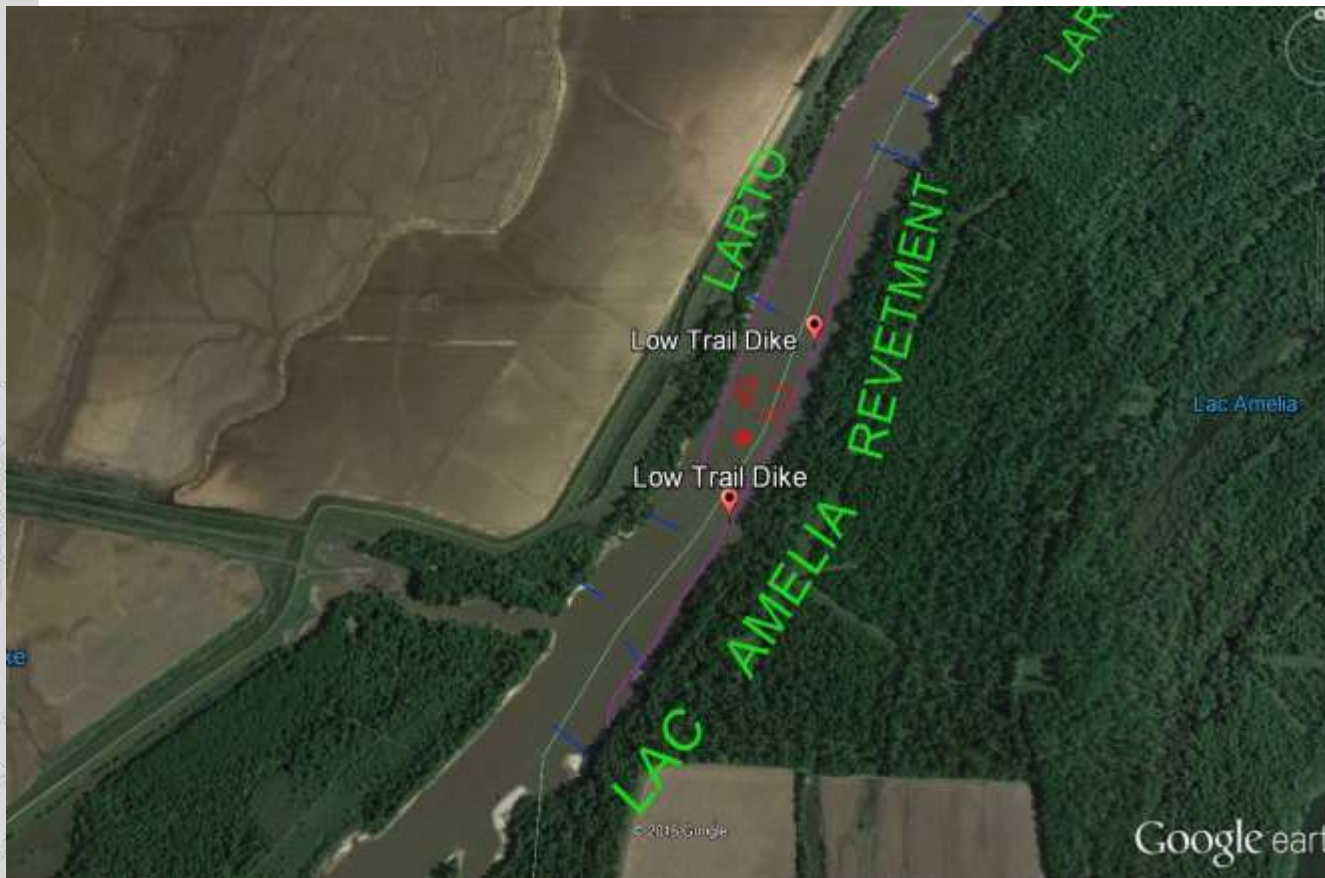
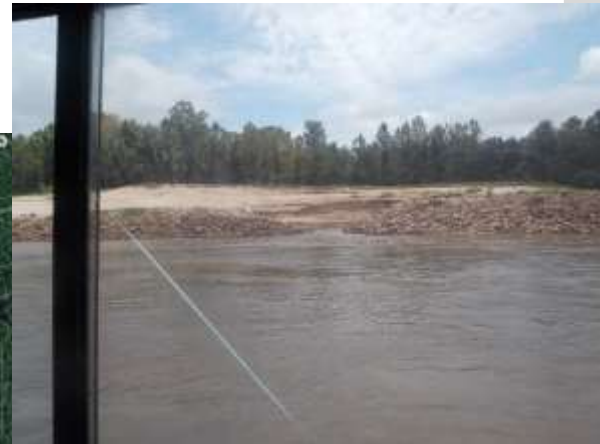
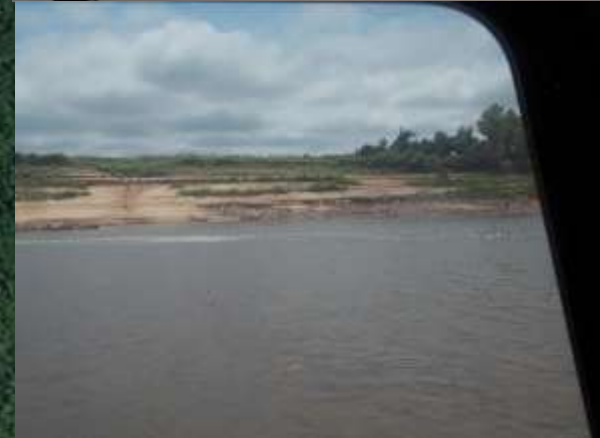
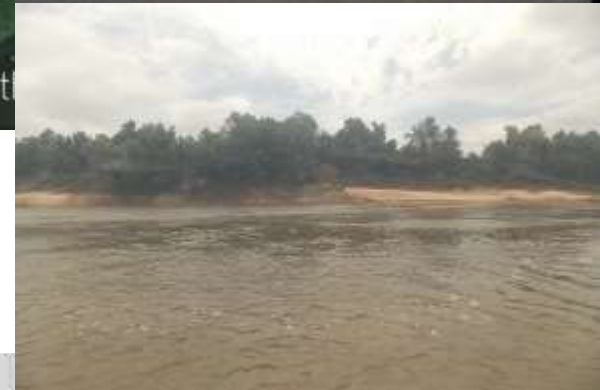
LAC AMELIA REVETMENT

RM 42.4 TO 41.6-R AHP

**Low Trail Dike Not Visible @ 12ft Water Depth
